REPORT

H-2, Heidarfjall

REMEDIATION PLAN FOR CONTAMINATED SOIL

DOC.NO. 20230273-03-R REV.NO. 0/2025-03-26

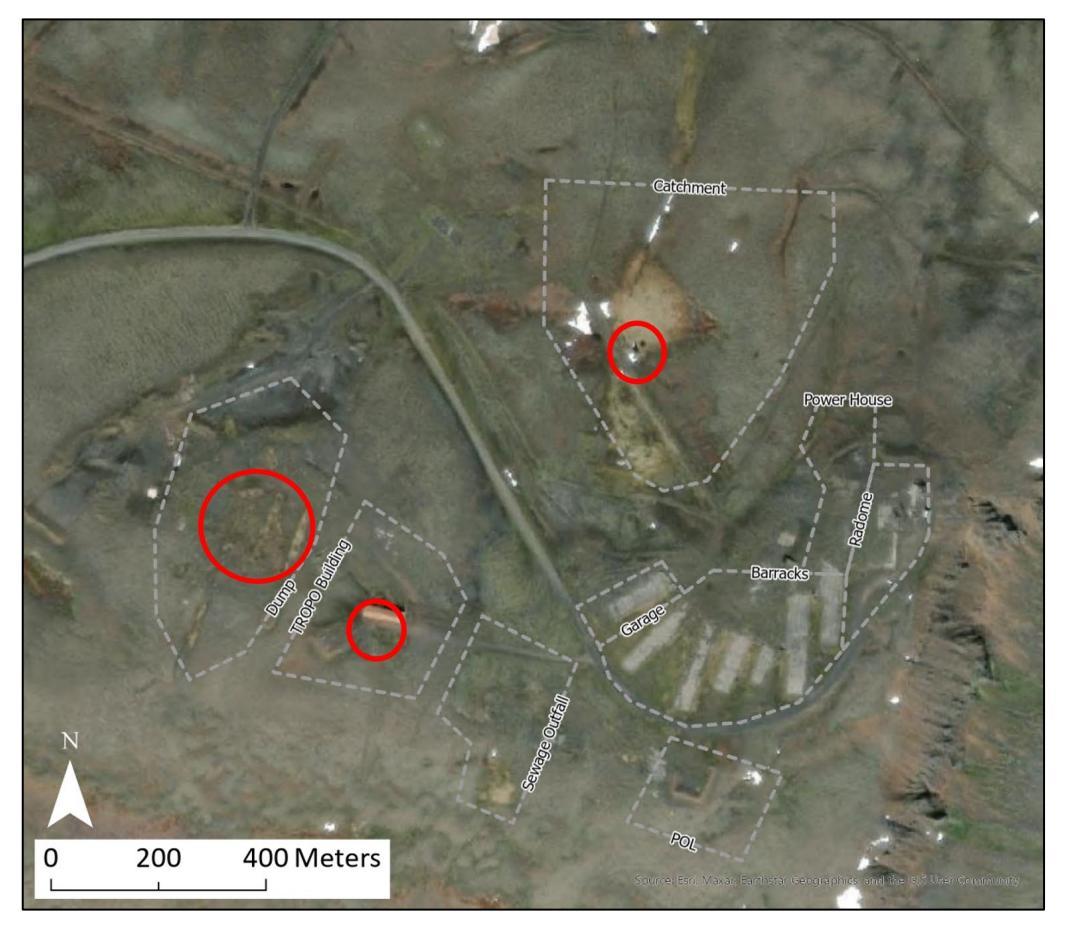
- The Dump Area. Lead (Pb) detected in soil next to weathered battery parts may cause an exceedance of the maximum tolerable daily intake (MTDI) for children. Oral intake of soil is the main exposure mechanism contributing to 70% of the total exposure.

- The Tropo Building Area. The levels of ∑PCB-7 detected in soil immediately south of the Tropo Building cause an exceedance of the MTDI for both children and adults. The main exposure mechanism is the consumption of fish from lake Eidisvatn. However, the risk of exposure by skin contact and oral intake also causes an exceedance of the MTDI in the calculations. The transient (time-dependent) contaminant transport model indicates that the ∑PCB-7 concentration in the water and fish downstream H-2 will continue to increase for >1 000 years if no remediation measures are done.

- **The Catchment Area.** The levels of Benzo(a)anthracene (BaA) and Benzo(a)pyrene (BaP) detected in a sediment sample from a small pond in the Catchment Area cause an exceedance of the MTDI for children. The main exposure mechanism is fish consumption. However, water drainage from the Catchment Area is likely towards the north, away from the lake where the landowners catch fish. The sediment sample also showed elevated levels of Cd, Hg, Cu, Zn, PAH, ∑PCB-7, VOC and petroleum hydrocarbons. The cocktail effect of these contaminants has not been assessed.

Figure 1-2 Approximate location of the three contaminant hotspots at H-2 in the Dump, Tropo Building and Catchment areas.

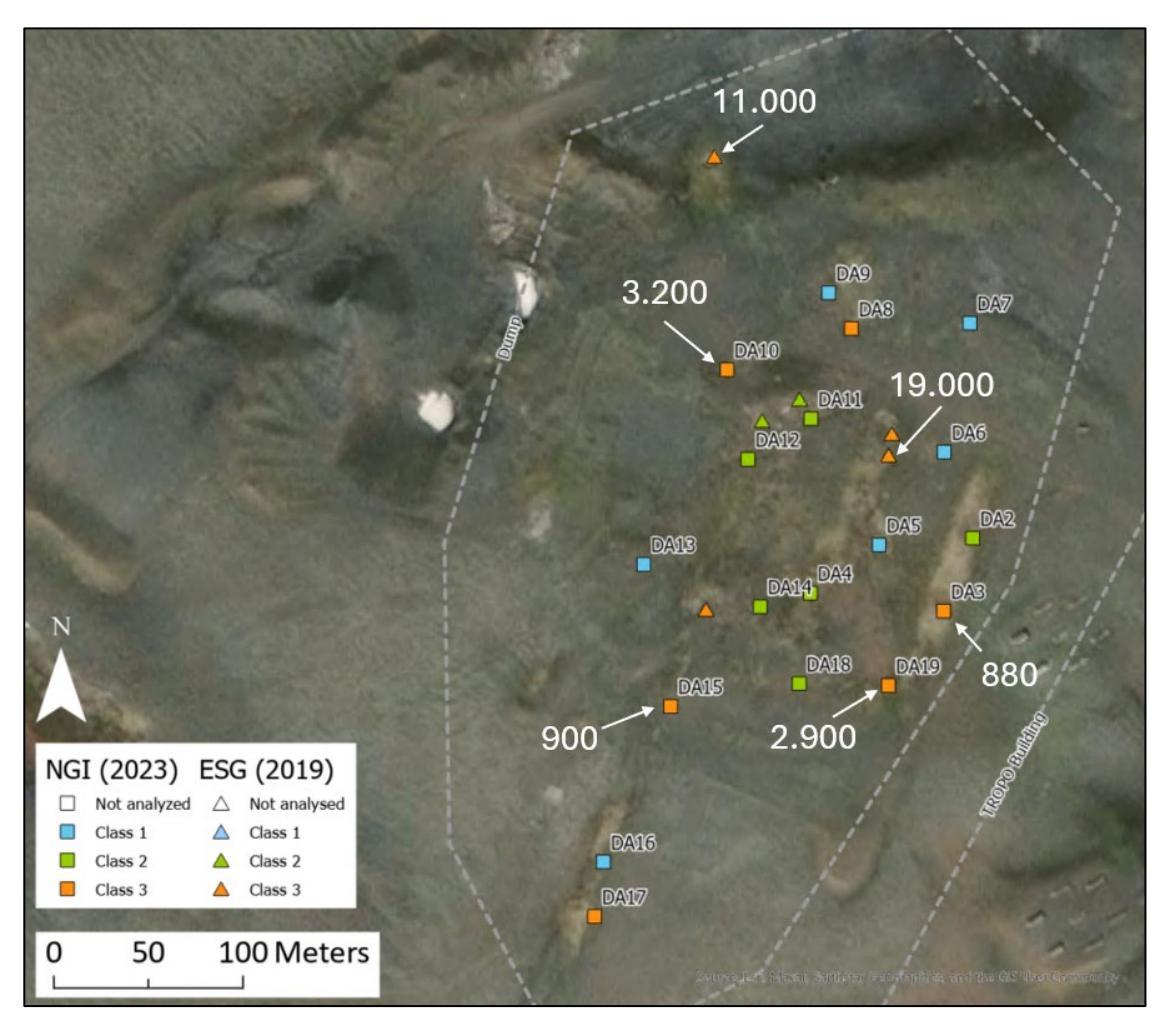
Figure 3-1 The Dump Area. Numbers denote the Pb-concentration (in mg/kg DM) detected in the soil samples. Only concentrations above the Icelandic acceptance criteria for the current land use is shown.

Soil represented by the samples that contain Pb-concentrations above the Icelandic acceptance criteria presented in regulation 1400/2020 must be excavated and removed from H-2 (Figure 3-1). It is recommended that soil represented by sample point DA17 is also be removed due to elevated concentrations of \sum PCB-7. Any debris/waste should be separated out before delivering the contaminated soil to a waste treatment facility. The soil must be excavated down to natural soil with no visible waste (expected to be minimum 1 m below terrain) or bedrock. If any Pb-batteries are observed during the visual inspection or during excavation, the soil within a 2 m diameter of the battery parts should be sampled and analysed (for documentation) and removed as well.

It is recommended to conduct supplementary soil sampling in the Dump Area before remediation to further delimit the contaminated soil and, possibly, reduce volume of soil that needs to be excavated and handled externally. If the delimitation is carried out during the remediation, samples can be analysed on site using a portable x-ray fluorescence (XRF) analyser.

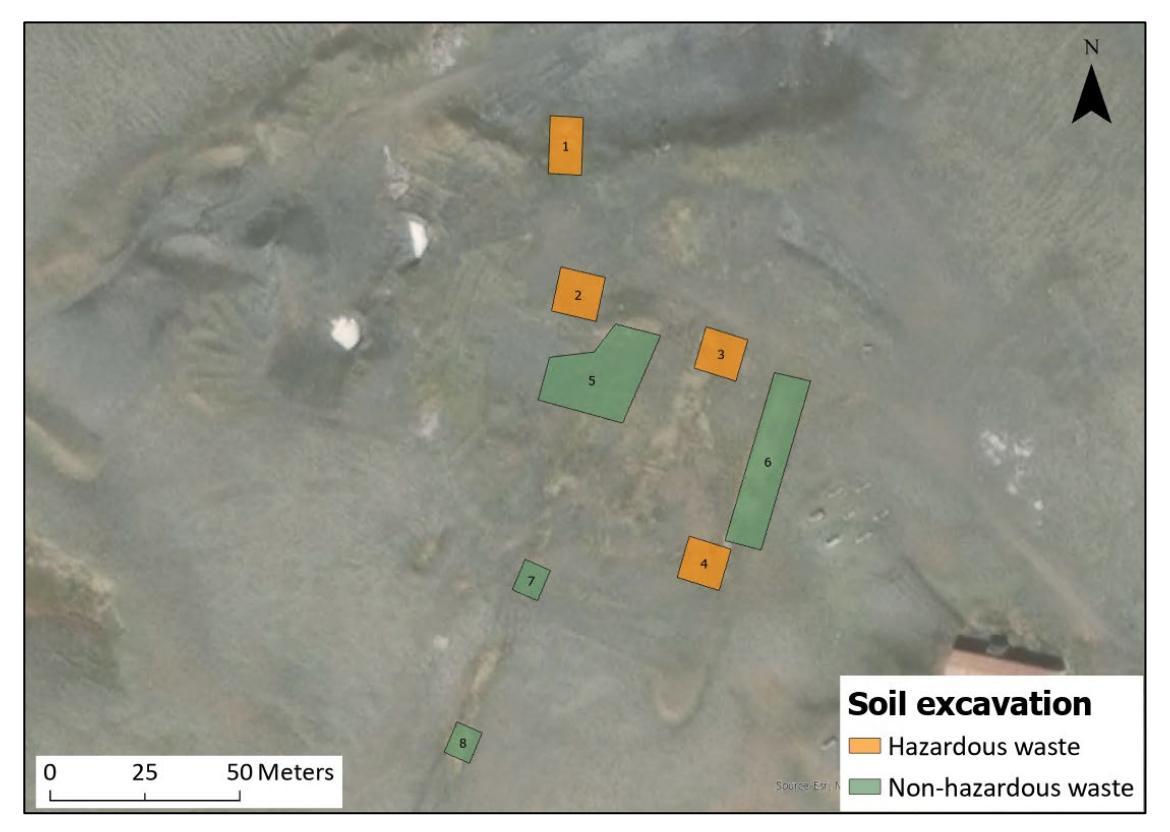
Figure 3-2 Excavation plan for the Dump Area based on expected waste categories.

An excavation plan has been prepared based on the analysed soil samples and the geophysical investigations presented in NGI (2024a). The 200 mS/m contour of the electromagnetic (EM) data has been used to delimit the areas to be excavated. The depth and excavation volume has been estimated based on the depth-to-bedrock model created from the ground-penetrating radar (GPR) data. The excavation plan is shown in Figure 3-2, while the expected waste categories (hazardous and non-hazardous waste) and estimated volumes are summarised in Table 3-1. Since the calculations are based on the depth-to-bedrock model, the volumes are expected to represent a maximum estimate. Pb-concentrations in samples from area no. 1 to 4 indicate that the soil can be considered hazardous waste according to the EU waste regulations. The soil within these four areas must be excavated and delivered to a waste treatment facility. The soil within area no. 5 to 8 contain lower levels of contaminants and should either:

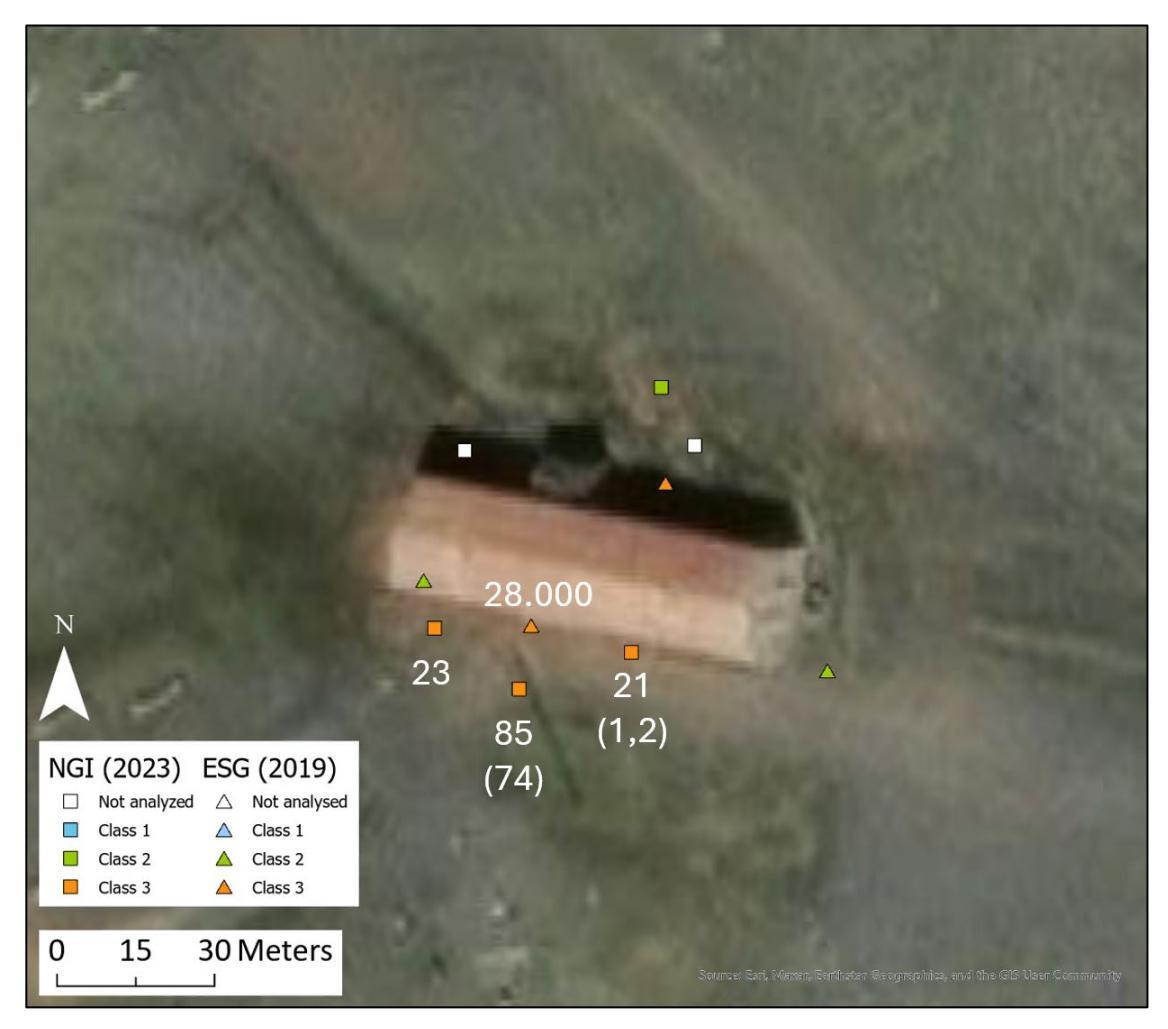
Measured \sum PCB-7 concentrations in soil samples are shown in Figure 3-3. The highest concentration (28.000 mg/kg) was measured on a sample of a patch of darkly stained soil next to the building. When handling contaminated soil, \sum PCB-7 concentrations above 50 mg/kg DM are considered hazardous waste according to the EU waste regulations. In addition, elevated concentrations of Pb, Zn and \sum PCB-7 have been detected in construction materials of the Tropo Building itself.

Figure 3-3 \sum PCB-7-concentrations (in mg/kg DM) detected in soil samples from the Tropo Building Area. Numbers without parenthesis represent topsoil (0 – 0,2 m depth), while numbers in parentheses represent the deeper soil layers (0,2 – 1 m depth).

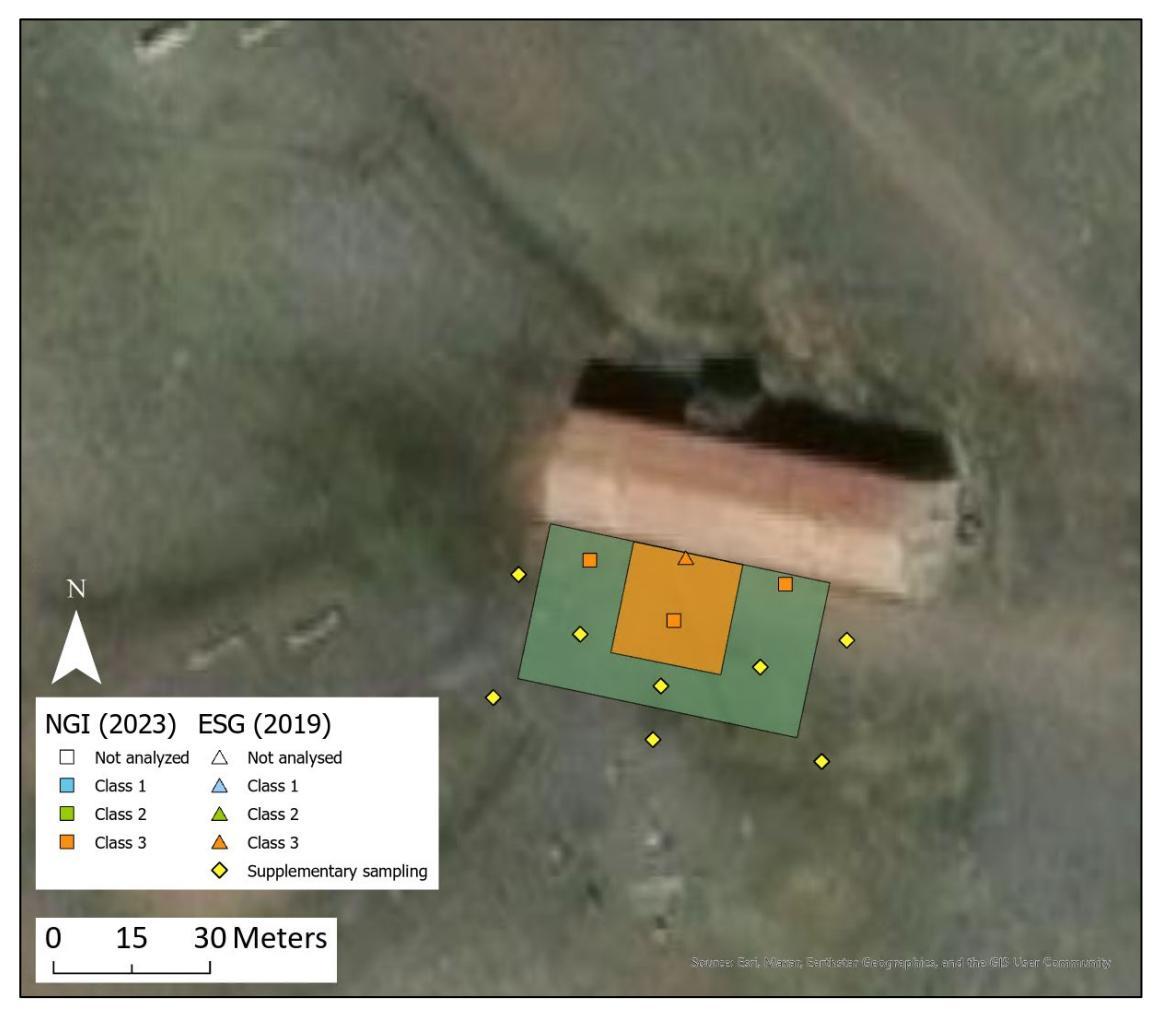
Figure 3-4 Suggested sampling points for supplementary soil investigations and excavation plan for the Tropo Building Area.

The excavation plan for the Tropo Building Area is shown in Figure 3-4. The soil must be excavated down to 1 m below the terrain surface or to bedrock if less than 1 m. The excavation plan should be adjusted based on the results of the supplementary soil investigations. The expected waste categories (hazardous and non-hazardous waste) and estimated volumes are summarised in Table 3-2. After excavation, samples from the bottom of the excavation pit should be collected and analysed for Σ PCB-7. The excavated soil should be replaced by clean soil from one of the abandoned gravel pits on Heidarfjall.

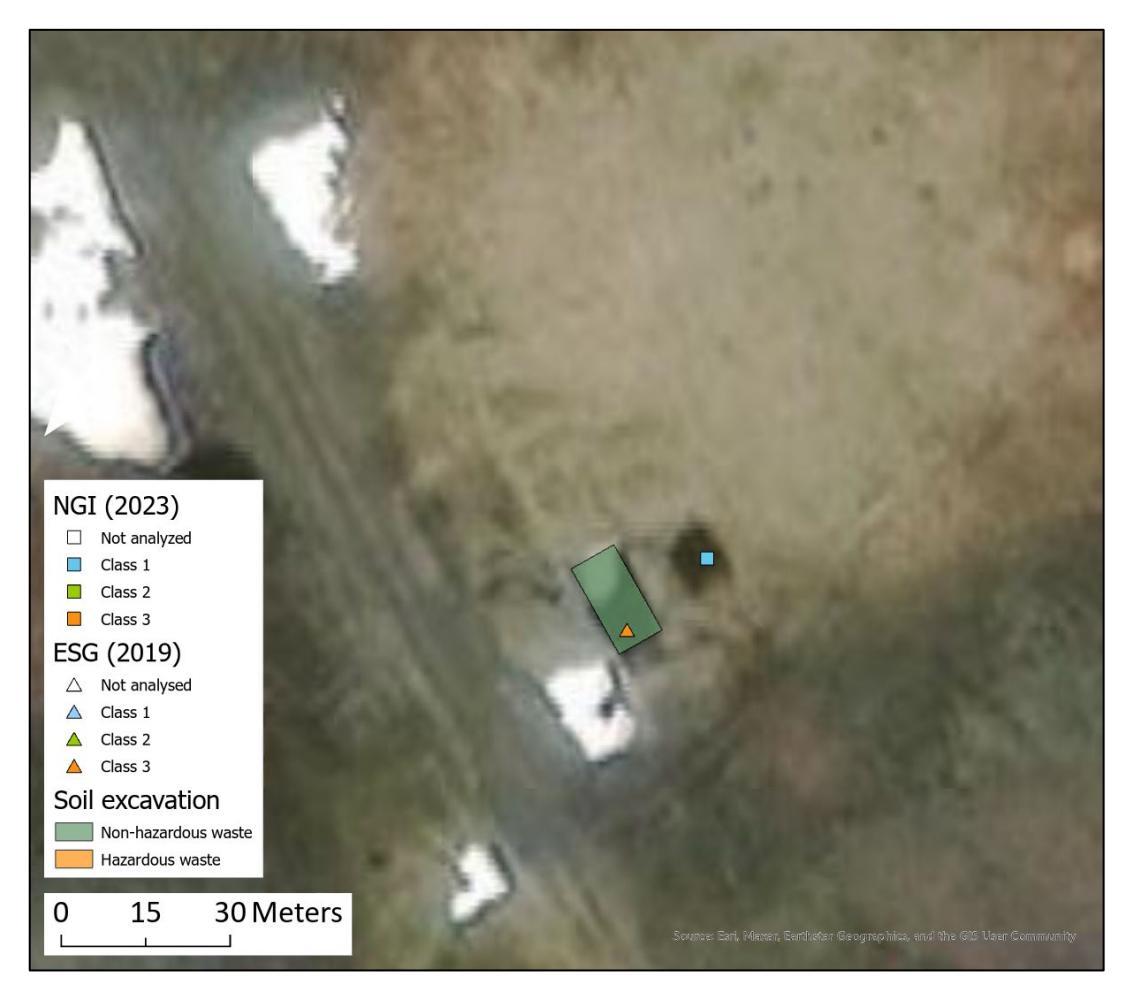
ESG (2019) reported a sediment sample from a small pond in the Catchment Area that contains elevated concentrations of Cd, Hg, Cu, Zn, PAHs, \sum PCB-7 and petroleum hydrocarbons. None of the individual concentrations indicate that it should be classified as hazardous waste. However, the cocktail-effect of multiple contaminants have not been

Figure 3-5 Excavation plan for the small pond in the Catchment Area.

The remediation plan involves removing the overlying 20-40 cm of water (e.g. by digging a trench and draining it), excavating the contaminated sediments and delivering them to a waste treatment facility. To ensure that sufficient of the contaminated sediments are removed, the pond should be excavated down to 20 cm below the transition into natural soil. The total volume is estimated to be approx. 15 m³. It is likely that the sediments will have a high water-content, and the contractor must consider choosing an appropriate container for transport.

After excavation, a sample should be collected from the bottom of the pit and analysed for the same contaminants as the samples which has already been collected.

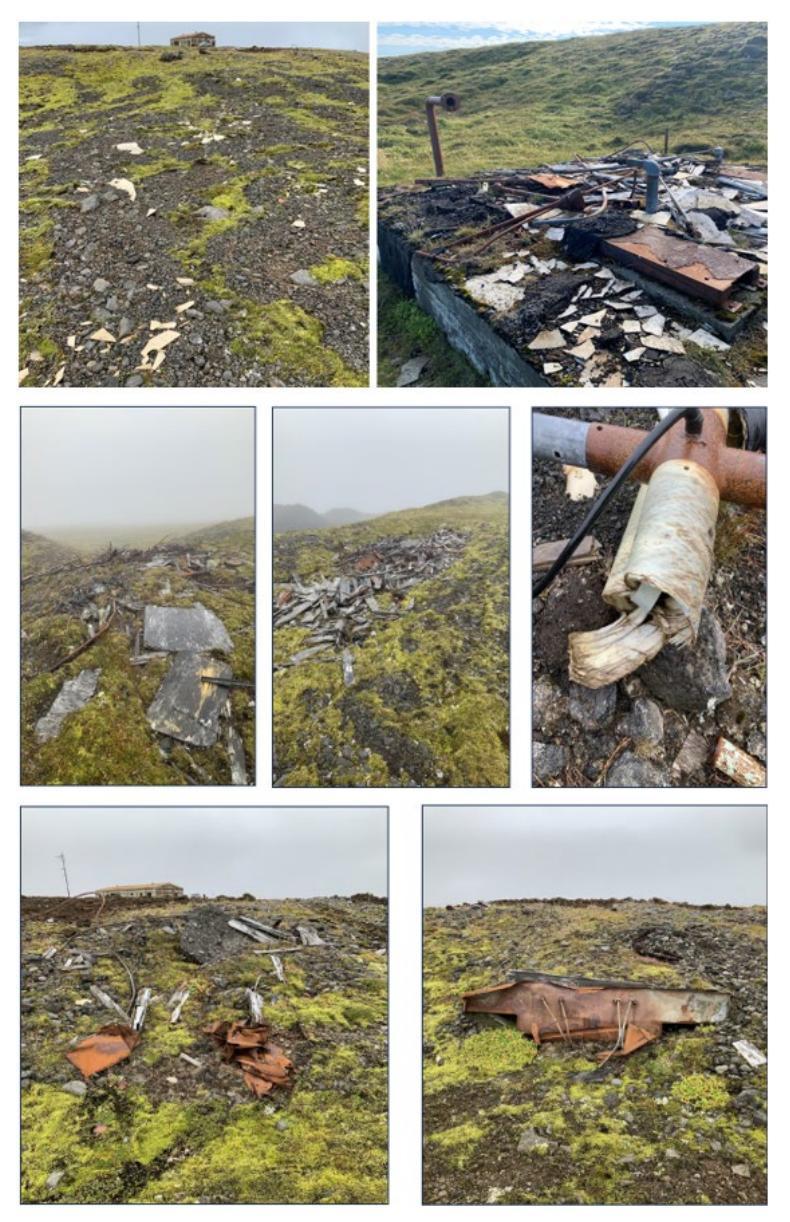
Figure 3-6 Examples of pale-yellow fragments of asbestos-containing building materials (top), wood debris and wires (center) and scrap metal, wires and wood (bottom) present on Heidarfjall.

Scattered waste and debris across H-2 should be collected, sorted according to waste type and handled according to national regulations. The waste includes loose pieces of scrap metal, wires and asbestos-containing building materials like Eternit. Examples are shown in Figure 3-6. Asbestos-containing building materials must be collected, packaged and delivered as asbestos waste to an approved waste handling facility in accordance with national regulations.
